RECOMMENDED IMPROVEMENTS

This chapter documents the recommended infrastructure improvements for South San Francisco as a part of the *Pedestrian Master Plan*. It is supported by the forthcoming Funding and Implementation chapter, the Pedestrian Design Guidelines, and lists of crosswalk, curb ramp and sidewalk inventories, which will be provided as appendices in the final plan. The following is a brief outline of this chapter.

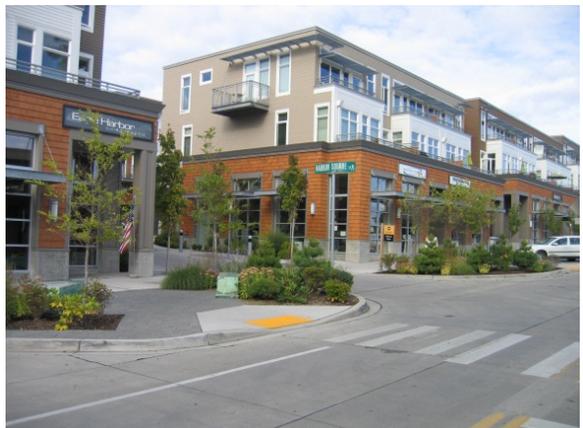
Example of bulb out with curb ramp and tactile domes

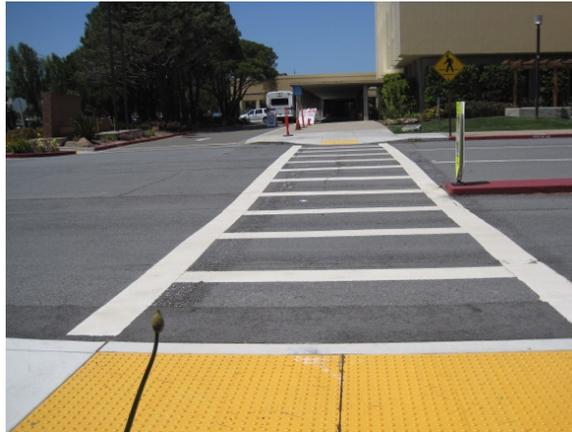
Ladder crosswalk and ADA accessible curb ramp with tactile domes

High visibility crosswalks, such as ladder striped crosswalks, should be considered at unsignalized crossings with high pedestrian volumes. One uniform high visibility crossing treatment should be used throughout the City. Crossings near schools should be marked in yellow to designate that they are located in a school zone. Additional crossing treatments may be applied in school zones to ensure safe crossing of students or at other unsignalized crossings designated as high risk areas. This may include advanced yield lines, commonly

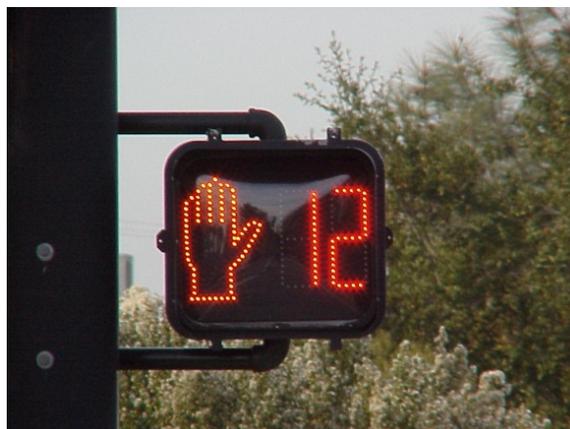
Pedestrian countdown signal

In order to ensure that pedestrians are aware of the remaining crossing time, pedestrian countdowns should be installed at all signalized intersections. California law requires that countdown signals be installed whenever signal control devices are being upgraded. At pedestrian actuated crossings, one pedestrian push button should be located adjacent to the curb ramp. Pedestrian push buttons for separate directions should not be located on the same pole. These buttons should be located on separate poles, separated by at least 3 feet.

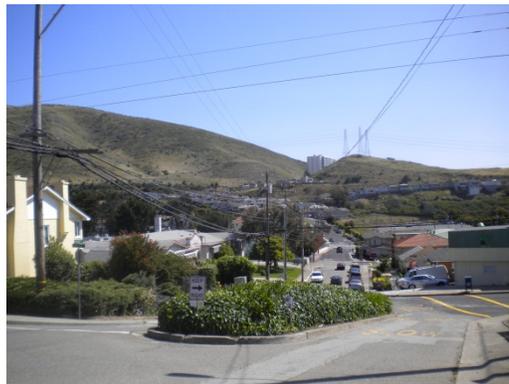
Median island in South San Francisco that functions as a traffic calming circle

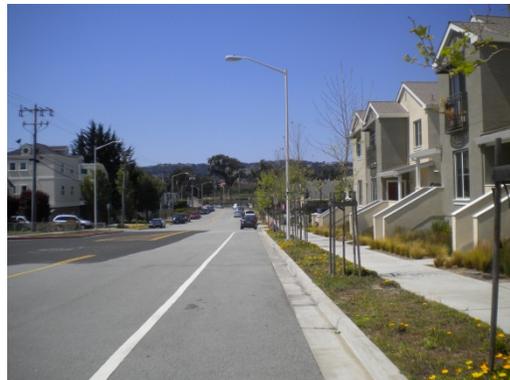
An edgeline demarcates the parking lane & edge of travel lane to reduce vehicle conflicts

avoid getting hit by oncoming vehicles, however this blocks the sidewalk for pedestrians. One simple measure included in the traffic calming program is to stripe edgelines along the roadway. Edgelines have the apparent effect of narrowing the roadway and therefore encourage drivers to drive more slowly. Painting edgelines with sufficient space for vehicles to park outside the sidewalk would also encourage vehicles to park on the street, rather than on the sidewalk. Education and enforcement measures can also be cost effective solutions, especially when residents are willing to volunteer for programs to address issues on their own streets.
